DESIGN AND PRODUCTION OF DAMAGE-RESISTANT TRAY PACK CONTAINERS

RICHARD D. CUMMINGS
JULY 1985
FINAL REPORT 1984-1985

CUMMINGS SOLAR CORPORATION
WILMINGTON, MASSACHUSETTS

UNITED STATES ARMY NATICK
RESEARCH, DEVELOPMENT AND ENGINEERING CENTER
NATICK, MASSACHUSETTS 01900
FOOD ENGINEERING DIRECTORATE

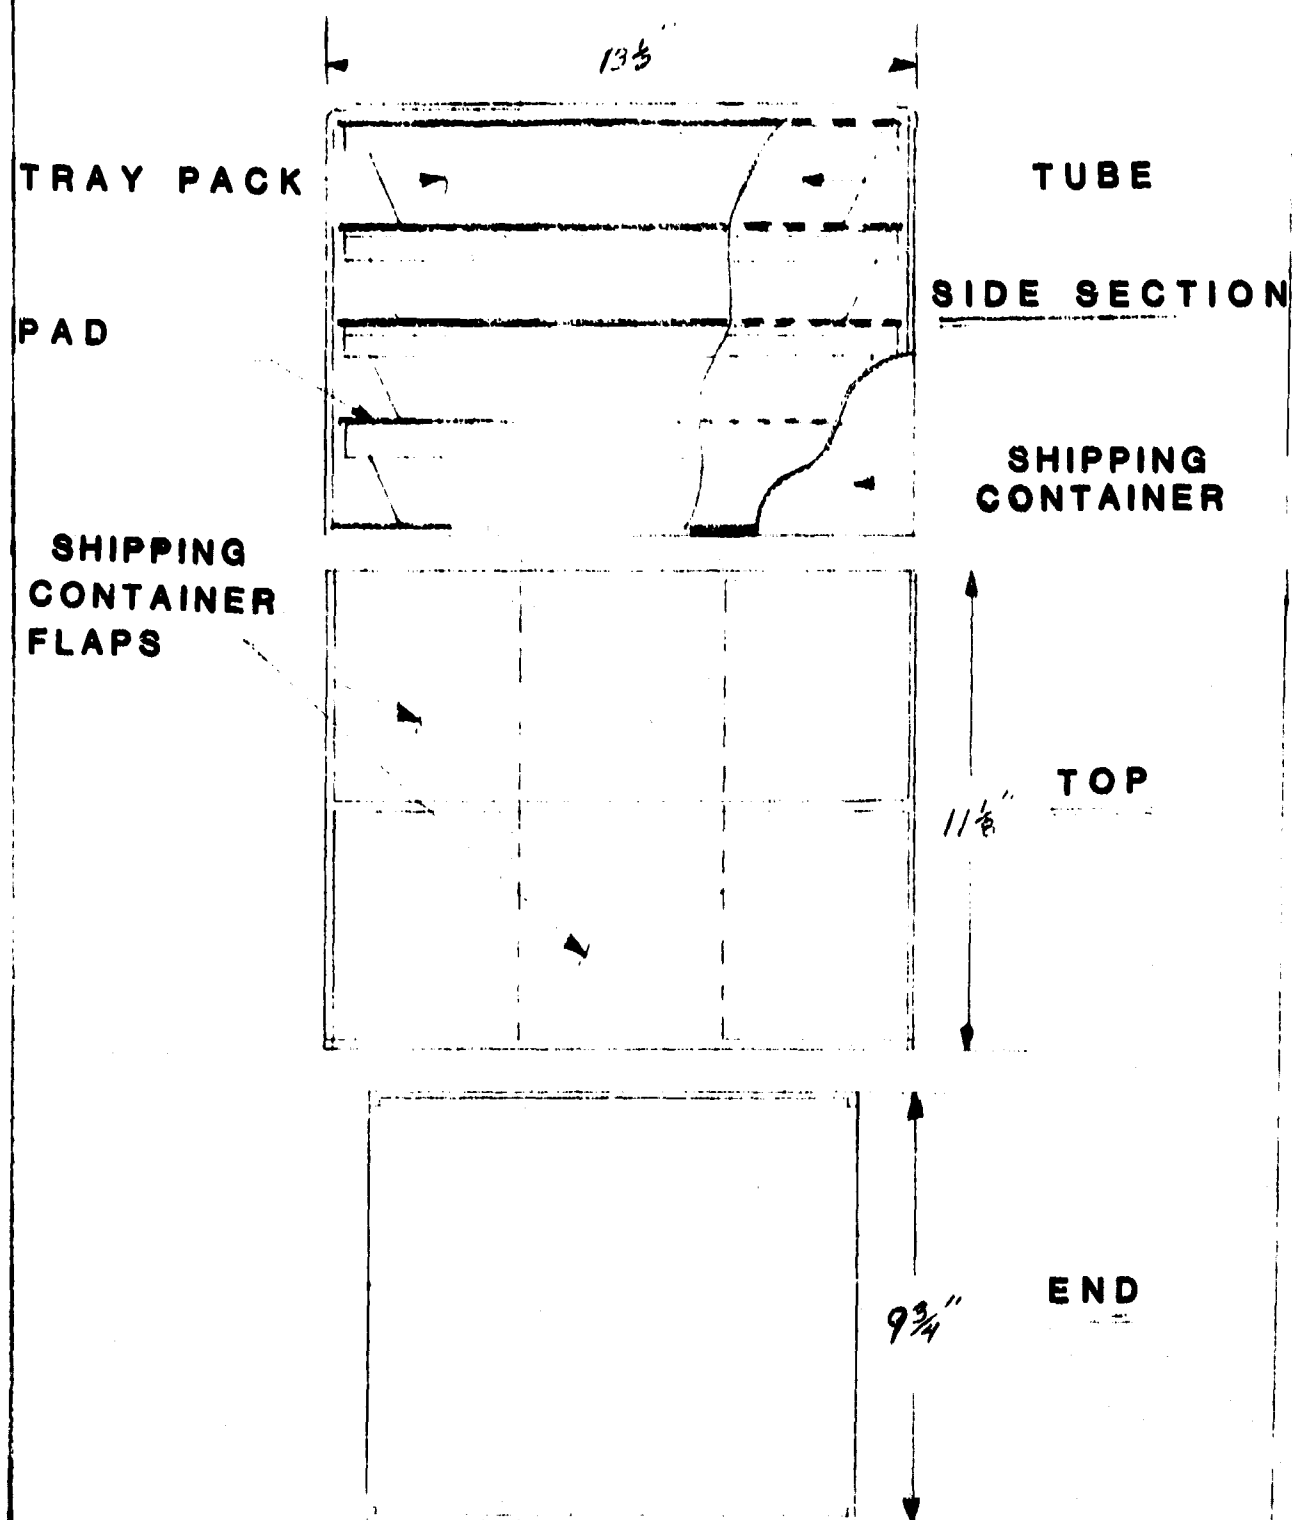
FIGURE 2. TRAY PACK SHIPPING CONTAINER

The first defect in the current design is the mismatch in the sizes of the parts of the shipping container and its contents. Specifically, the fiberboard shipping container sidewalls are taller than the liner sidewalls and the liner sidewalls are taller than the ensemble of Tray Packs and fiberboard pads. Therefore, a crushing load is first applied to the shipping container sidewalls. These sidewalls buckle when the load exceeds their strength and the entire load is shifted to the fiberboard liner. The load then collapses the liner and the load is shifted to the ensemble of Tray Packs and fiberboard pads. The pads are then dented along the perimeter of the sealing seam leading to more deflection. The Tray Pack ensemble then bears the entire load. However, at this point, the shipping container has been deflected by as much as an inch.

A second design defect is the concept of the pads being sized to the inside dimensions of the liner so that they rest

A third design defect is that the sidewall and the liner are really not sufficiently strong to bear the stacking load and three layers of fiberboard rather than two are needed.
